F-5-96

Jones-Mount Farmstead

F-5-96
Jones-Mount Farmstead
Monrovia
Frederick County

Maryland Historical Trust State Historic Sites Inventory Form

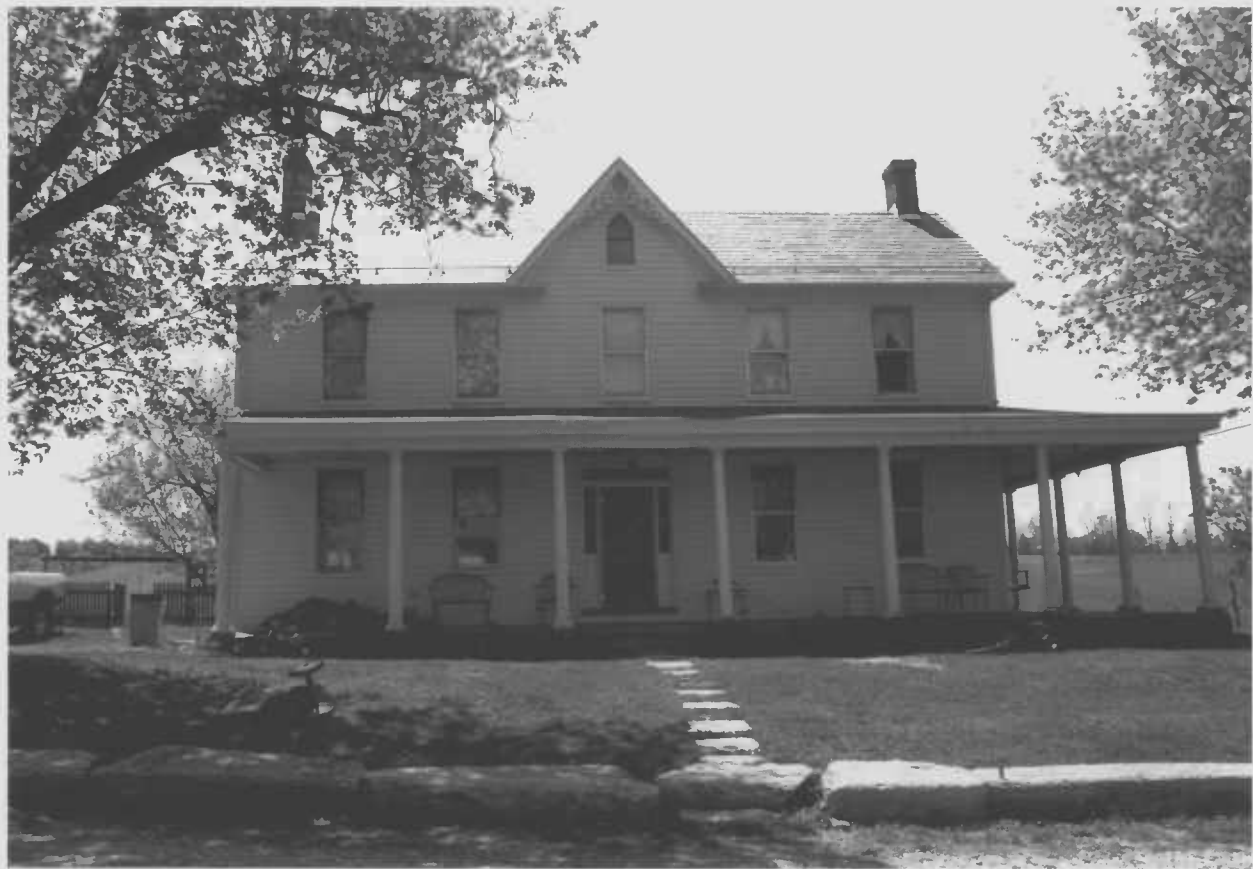
1/8

The dwelling may replace an earlier structure on about the same site, as the 1858 Isaac Bond map shows that N. Jones (Nathan Jones, according to land records) had a building on the property. The proportions and decoration of the house, however, indicates a later date than 1858, probably about 1875. The principal section of the house has a five-bay elevation facing north with a central cross gable with scroll-sawn ornamentation in the gable peak and a Gothic arched at window. The two-story rear wing extending from the southwest corner has a another cross gable, mirroring the west gable end of the main section. Each has twin Gothic arched windows above two bays on the lower floors. A side entrance to a cross hall is located at the junction of the two gable sections. The exterior of the house is covered with german siding and the roof is slate on the north slope and composition shingles on the south slope and rear wing. Interior end chimneys are at each gable end, including the west gable of the rear wing. The windows are 1/1 replacement sash and shutter hardware still in place on the window frames indicates that the ubiquitous louvred shutters of the late 19th century have been removed. A one-story veranda extends across the entire north and west elevations. Tuscan columns support the roof and the base is concrete. While the house probably had a porch from its first construction, this porch is probably an early 20th century enlargement. The original porch may have been on both elevations, but more likely had turned columns and perhaps a scroll-sawn balustrade between the uprights. The center doorway on the north elevation has a two-light transom and sidelights with a 6-panel door. The east side of the rear wing shows a two-story integral porch with the upper level enclosed. Gothic arched windows are in the southern bay on both floors. The single turned column in the center of the open first level suggests the probable profile of the original columns of the main elevation porch.

North elevation

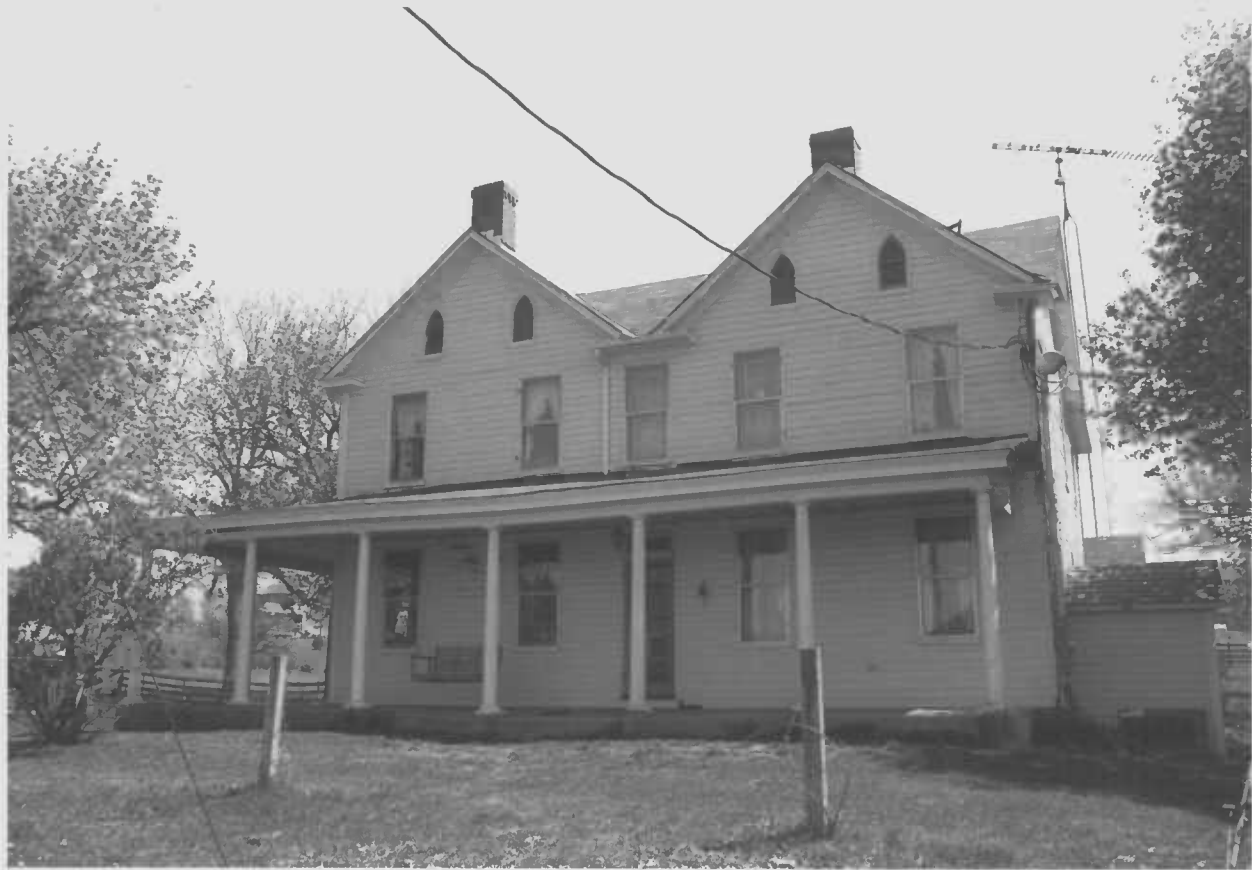
2/5

West elevation

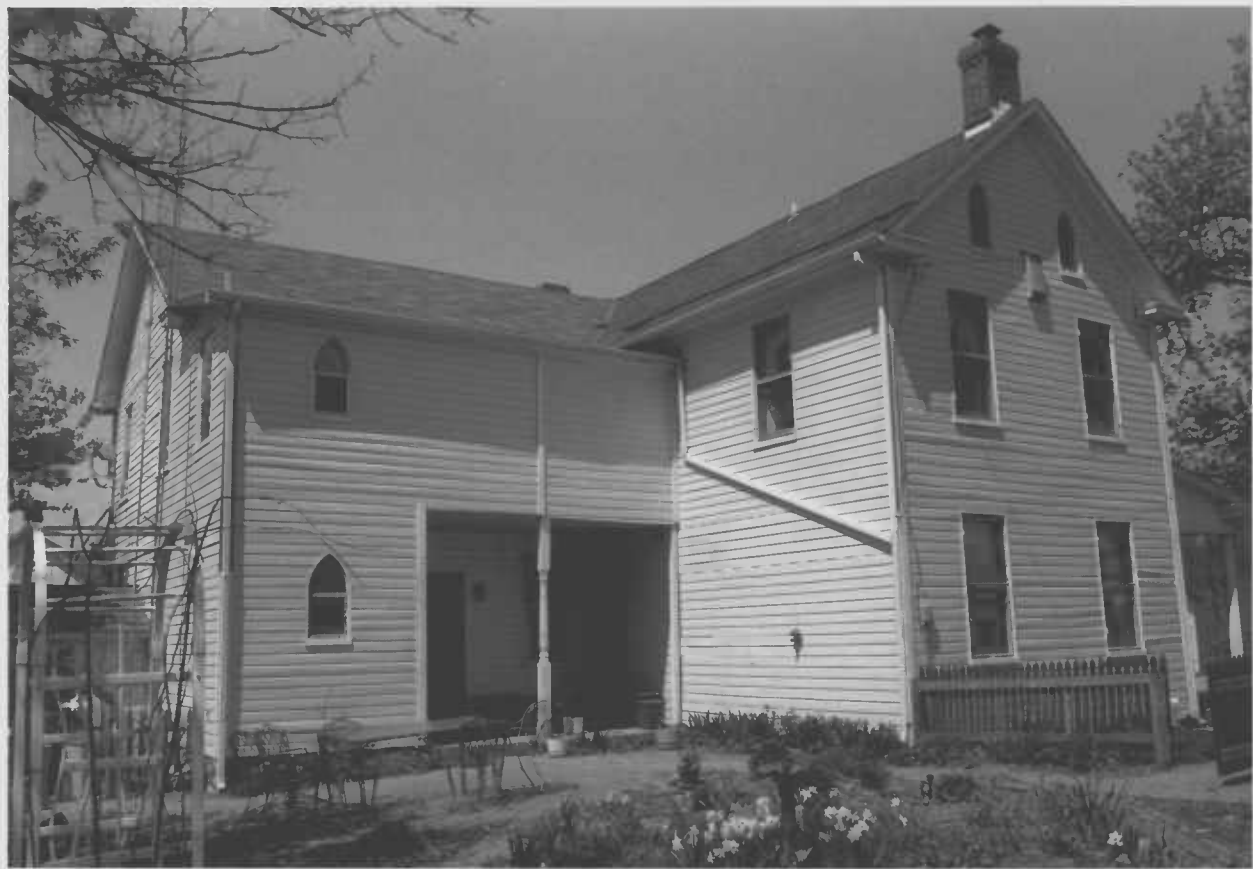
3/8

Southeast corner view

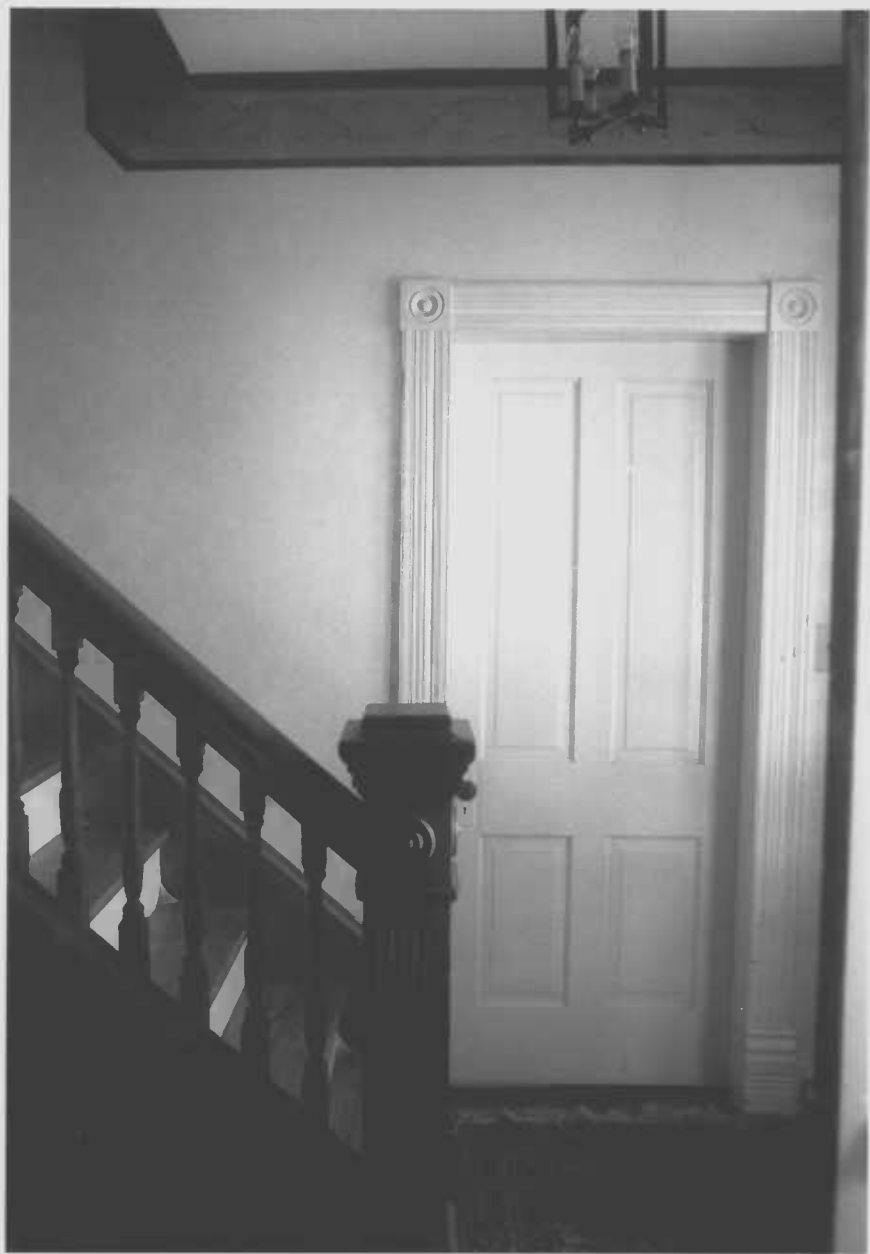
4/8

The interior of the house has its original molded door and window trim with bull's-eye corner blocks. The square newel post of the main staircase in the central hall terminates the railing with a turned balustrade. Recent remodeling of the house revealed a circa 1875 stenciled wallpaper border in the hall over which 20th century wallpaper had been applied. The running floral border was left exposed above the modern wallpaper in the hallway. In the west parlor is a carved wood

Central hall from end of "border"

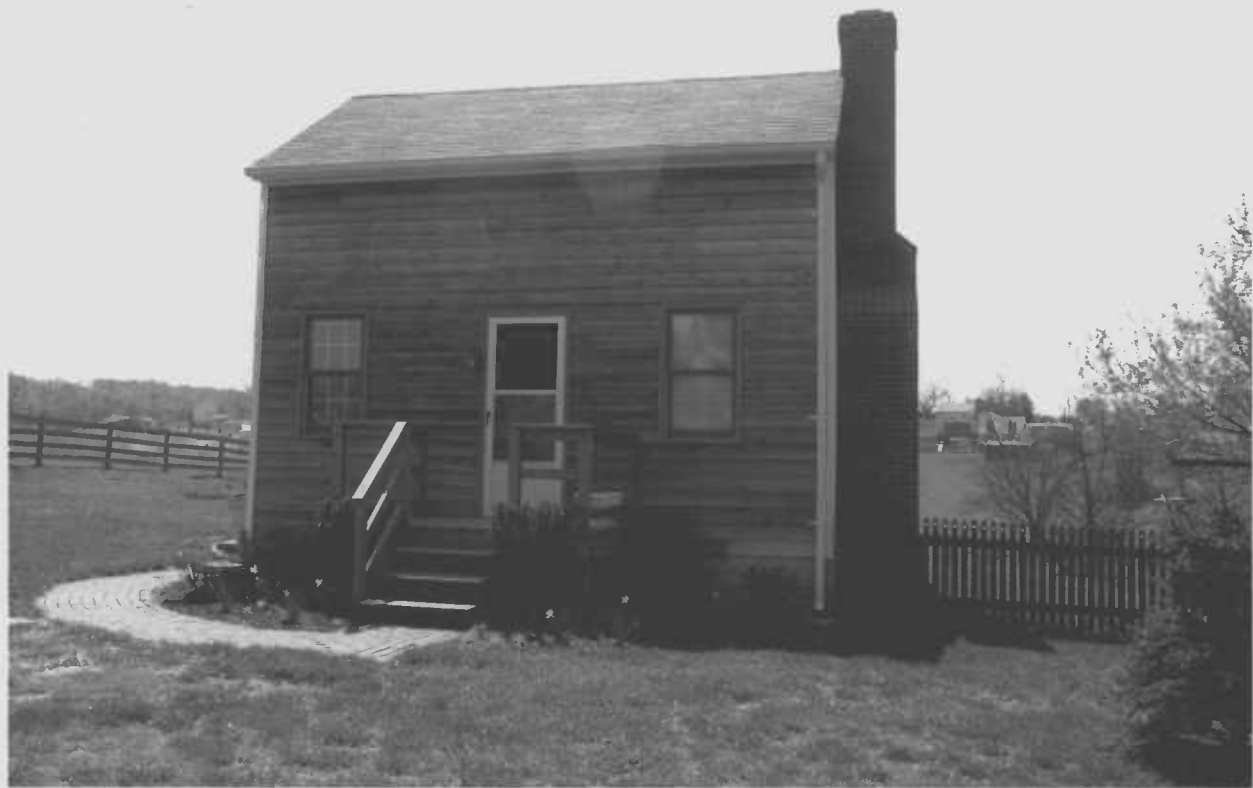
5/8

Summer kitchen: The frame summer kitchen is a one-story building with a raised roofline added when the circa 1870's structure was moved from a more distant location to a site just east of the main dwelling to be remodeled as a tenant house. The exterior now has modern clapboard siding, new 6/6 sash and a door with a wood stoop on the north elevation. A new exterior brick chimney is on the west elevation.

Remodeled summer kitchen, north elevation

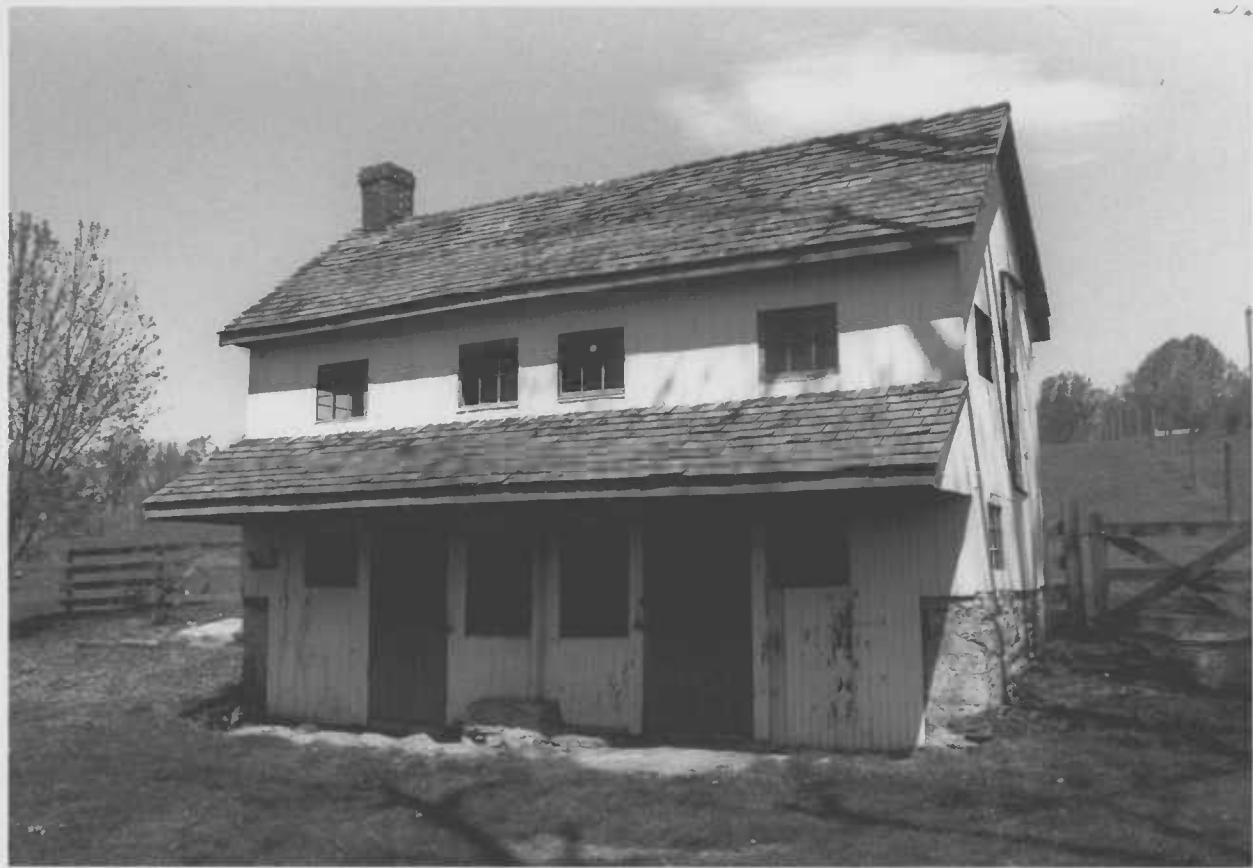
6/8

Chicken house: Facing the north elevation of the main dwelling is a two-story frame building with a tongue-and-groove exterior and a pent roof sheltering the south elevation first story. Above the pent are four small 3/3 windows. The first story has two vertical board doors with matching flanking window openings, a single 9-light window in the center bay and a 3/3 window in the outer bay. The building is set on a raised stone foundation visible on the east, west and north elevations. Both the main roof and the pent roof have wood shingles. An interior chimney for a stove is located at the west gable end. A loft loading door is on the east gable end. The presence of this door and the varying window size on the south indicate that the building was a chicken house with feed storage on the loft level. It appears to date from about 1875-1890.

Chickens house, south elevation

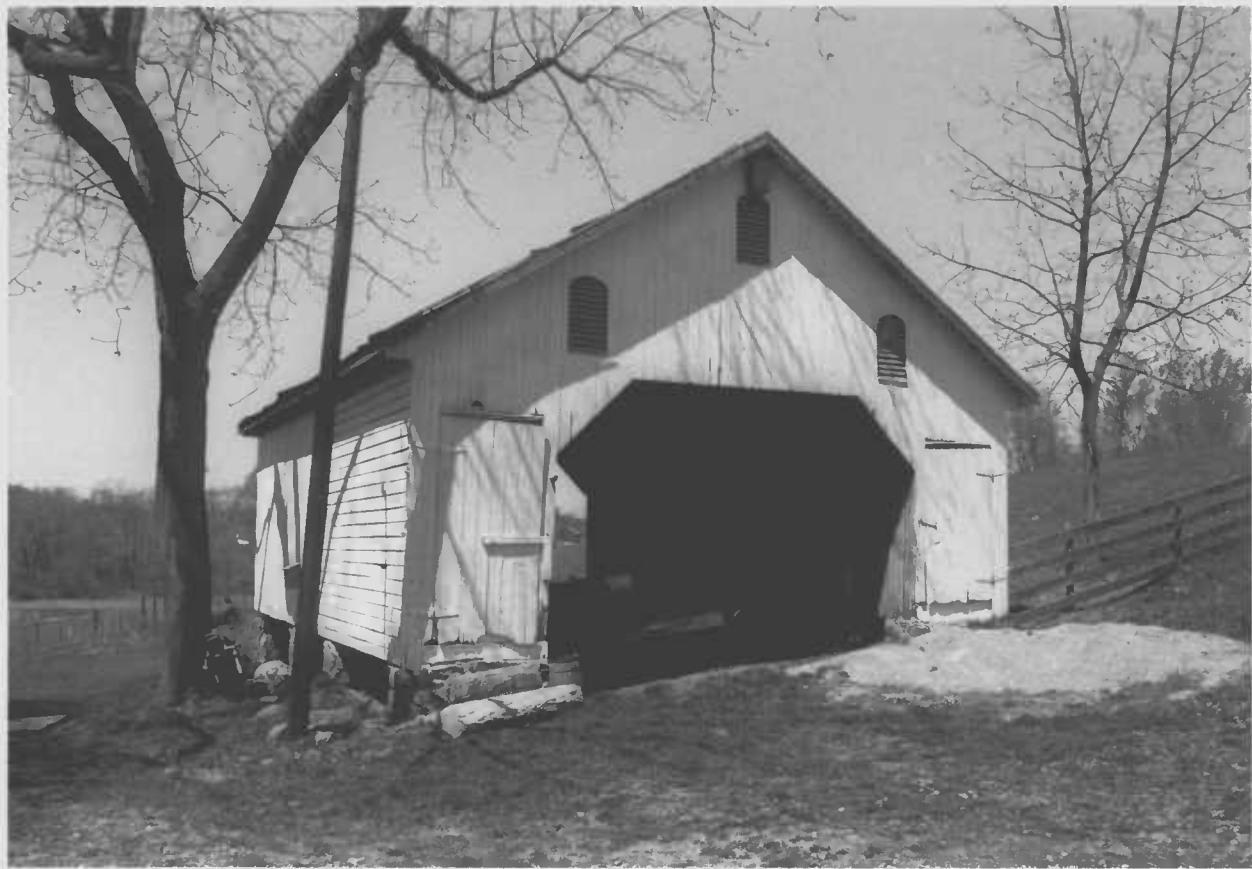
7/8

Wagon shed/corn crib: The frame wagon shed corn crib is located west of the chicken house. It has vertical tongue-and-groove siding on the east and west gable ends and louvred arched vents in the east elevation. The north and south sides of the cribs have horizontal vented siding and are raised on stone piers. At the southwest corner is a section of the crib with vertical tongue-and-groove siding, indicating a section for wheat or other grain storage. The wagon shed was built about 1875-1890.

Wagon shed/corn crib, east elevation

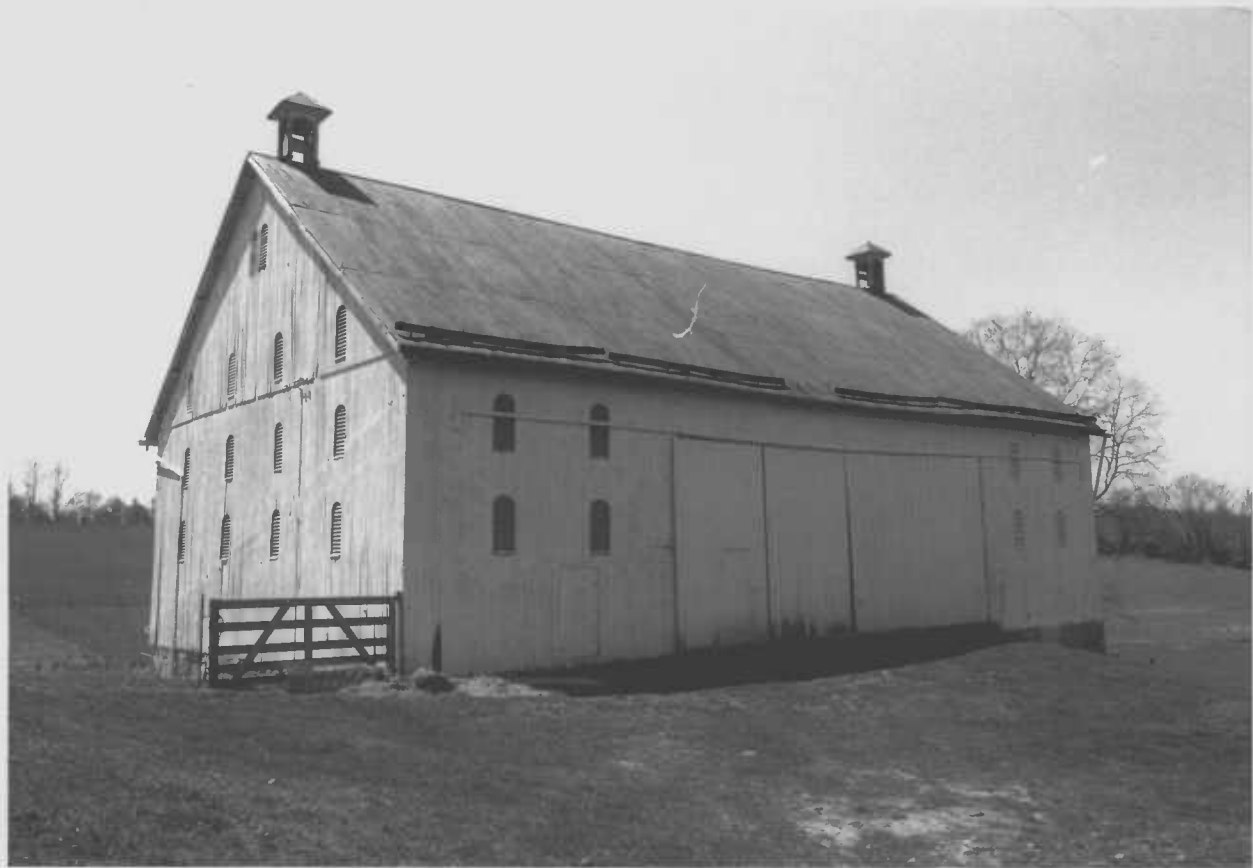
8/8

Bank barn: The frame bank barn located southwest of the dwelling has a stone foundation which may date from the 1850's farmstead that is indicated on the 1858 Bond map. The present upper structure, however, appears to date from the 1870's to 1890's. The siding is tongue-and-groove with a corrugated roof over wood shingles. Louvred arched vents are in the walls and two deteriorated louvred cupolas are at each end of the roof ridge. There is the ghost of a third cupola in the center of the roof. The sliding doors on the north elevation were a later addition, the originals undoubtedly having been double swing doors. The concrete threshold has the inscribed names of "Stanley" and "Kitty" and the date Nov. 18, 1944. These names are as yet unidentified, but could have been those of tenant farmers or contractors improving or repairing the barn in the 1940's.

Bank farm. north elevation
